**NORTH KIGEZI & KINKIIZI DIOCESES
WATER AND SANITATION PROGRAMME
(NKKD WATSAN)**

**3rd Quarterly Report
July – September, 2018**

C.1.1. BWAMBARA HILL WATER SUPPLY AND SANITATION IMPROVEMENT PROJECT (BWAMBARA HILL PROJECT)

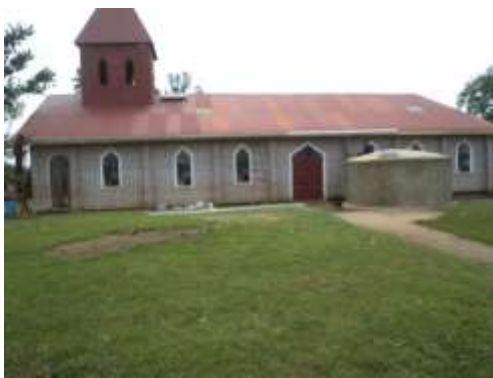
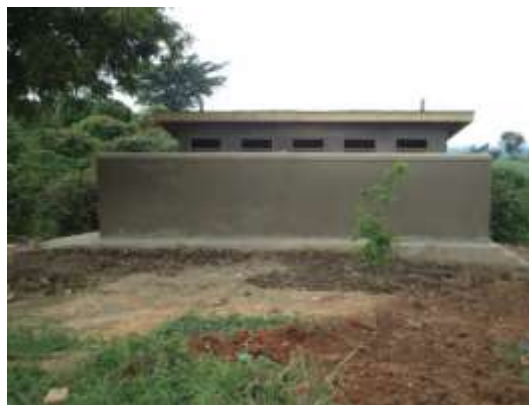
(a) One (1) 30m³ ferro-cement Rain water harvesting tank

(b) One (1) lined 5 stance Pit (VIP) latrine with a urinal. Construction of both structures was finished.

30m³ Rainwater harvesting tank and a 6 stance Pit latrine that were constructed at Bwambara Church

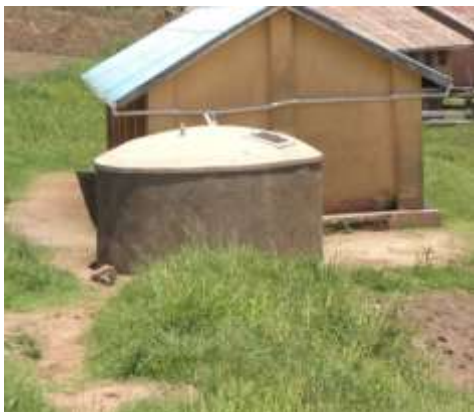
(a) Two (2) 30m³ ferro-cement Rainwater harvesting tanks. Construction of one tank was finished while for another was still on-going.

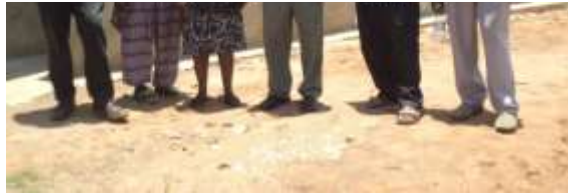
3. Bwambara Senior secondary school
 - One (1) 6 stance lined pit latrine for boys. Was finished.

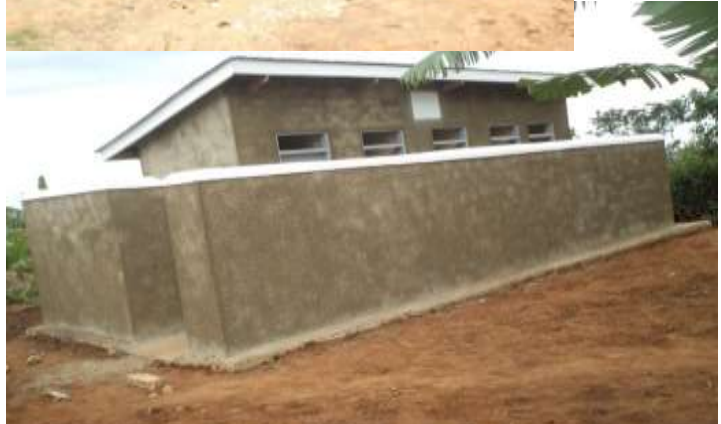
A 6 stance pit latrine for boys constructed at Bwambara SSS

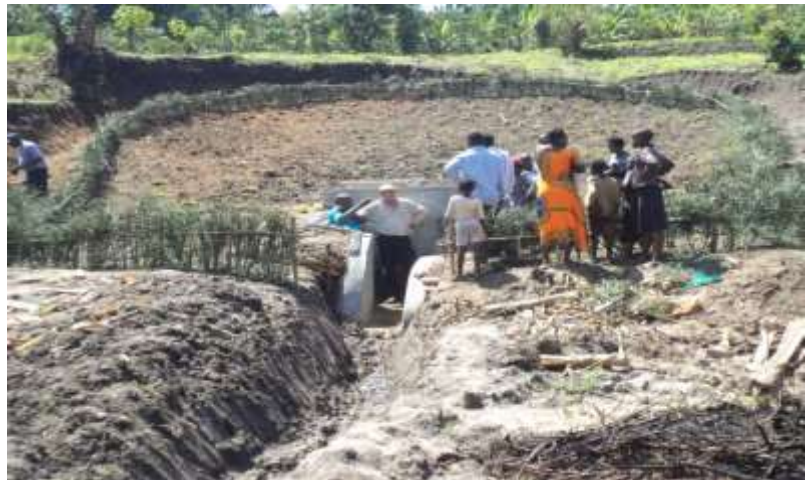
4. Bwambara town
 - (a) One (1) low yield spring. Construction was finished.

Supervision of the finished construction of Bwambara spring by WATSAN Staff together with the visiting of Andrew Maclean

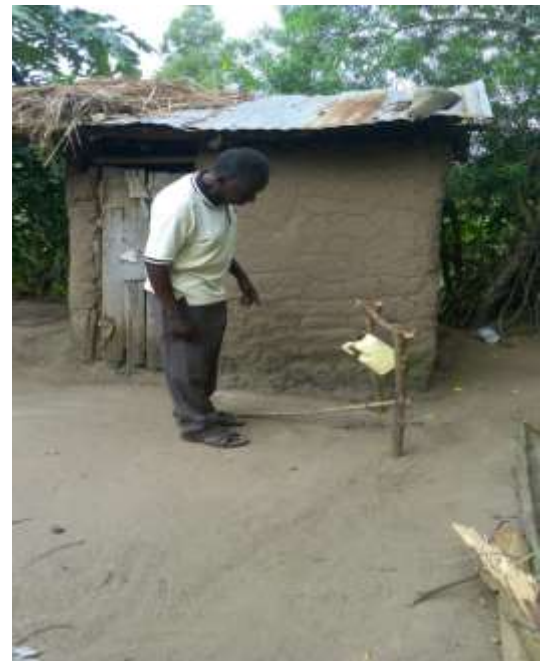
- Brick masonry super structure and placing of door frames
- Placing of vent pipes
- Roof construction
- Plastering walls with sand cement plaster in ratio (1:3)
- Placing of door shutters
- Painting the walls
- Backfilling with ordinary soils cleaning and shaping the area

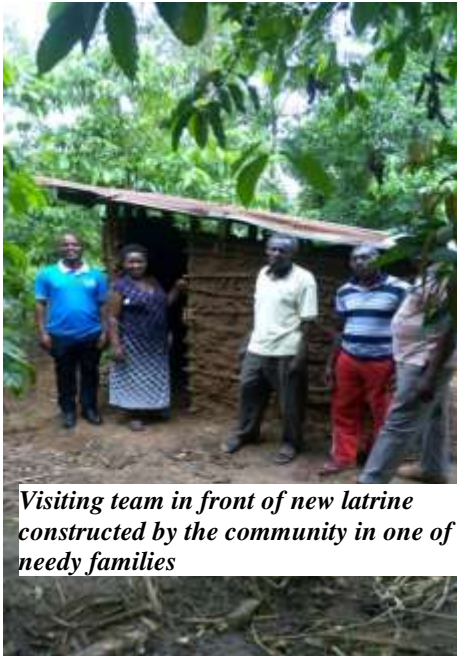
Visiting team in front of new latrine constructed by the community in one of the needy families

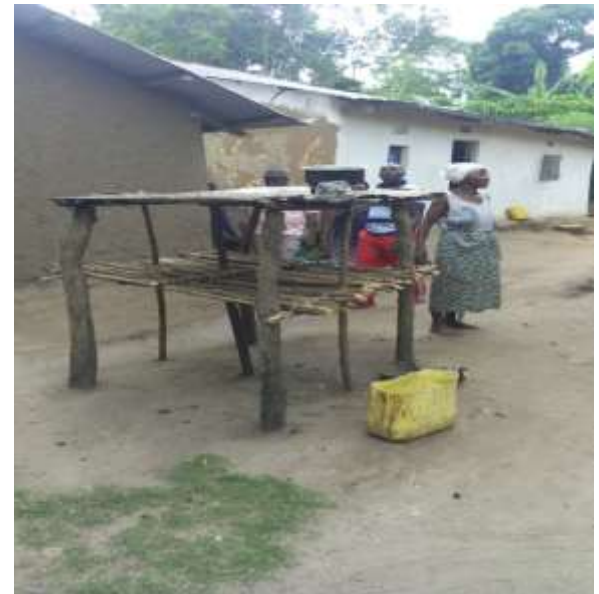
The existing water source of Bwambara spring I was fenced and community

actively participated both in fencing and in

the construction of Bwambara spring 2

which is adjacent to the existing spring. The newly constructed spring (Bwambara spring 2) is expected to serve a population of 1197 peoples, from 171 families in the cells of Bwambara Trading Centre, Rushaya B, and Rugyera, and 4 institutions of Bwambara P/s, Bwambara SS, Bwambara archdeaconry centre and PAPEE Primary School (PAPEE is a private owned primary school).

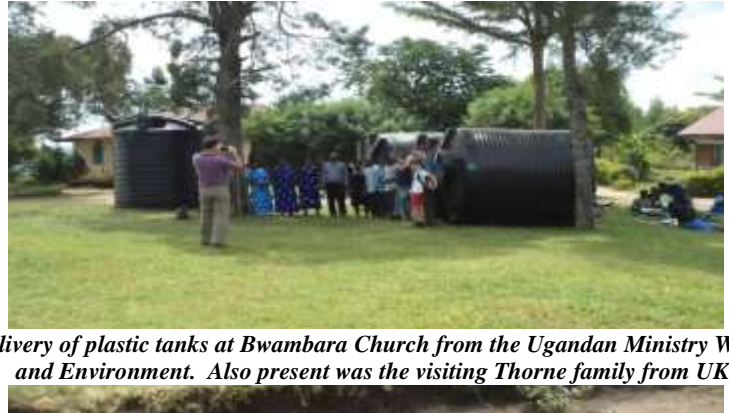
Delivery of plastic tanks at Bwambara Church from the Ugandan Ministry Water and Environment. Also present was the visiting Thorne family from UK

4 plastic tanks, each with a capacity of 10,000 litres were supplied by the Minister of Water and Environment to

Bwambara Hill Project to help in the roof water catchment, thus augmenting water supply in this area. The distribution of these tanks was one (1) tank to 4 institutions namely:

- i) Bwambara Church, at the Archdeacons house
- ii) Bwambara Primary School, at staff quarters
- iii) Bwambara Secondary school, at staff quarters
- iv) PAPEE Primary school, at the school main hall

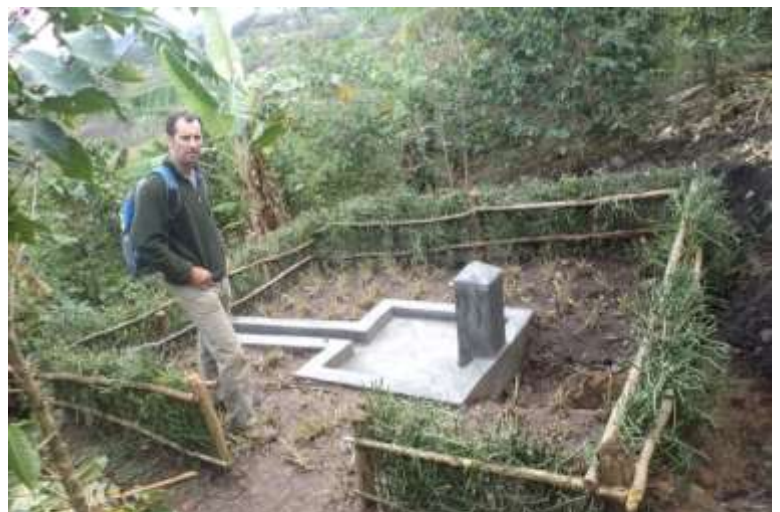
Constructed tapstand at Ndere water supply being appreciated by Ben Thorne from UK

4. Tapstand construction: 3No. single faucet tapstand were constructed and connected with water. Two of these tapstands were constructed uphill near the water source while the third tapstand was constructed 400,000 metres away from the source down the hill.

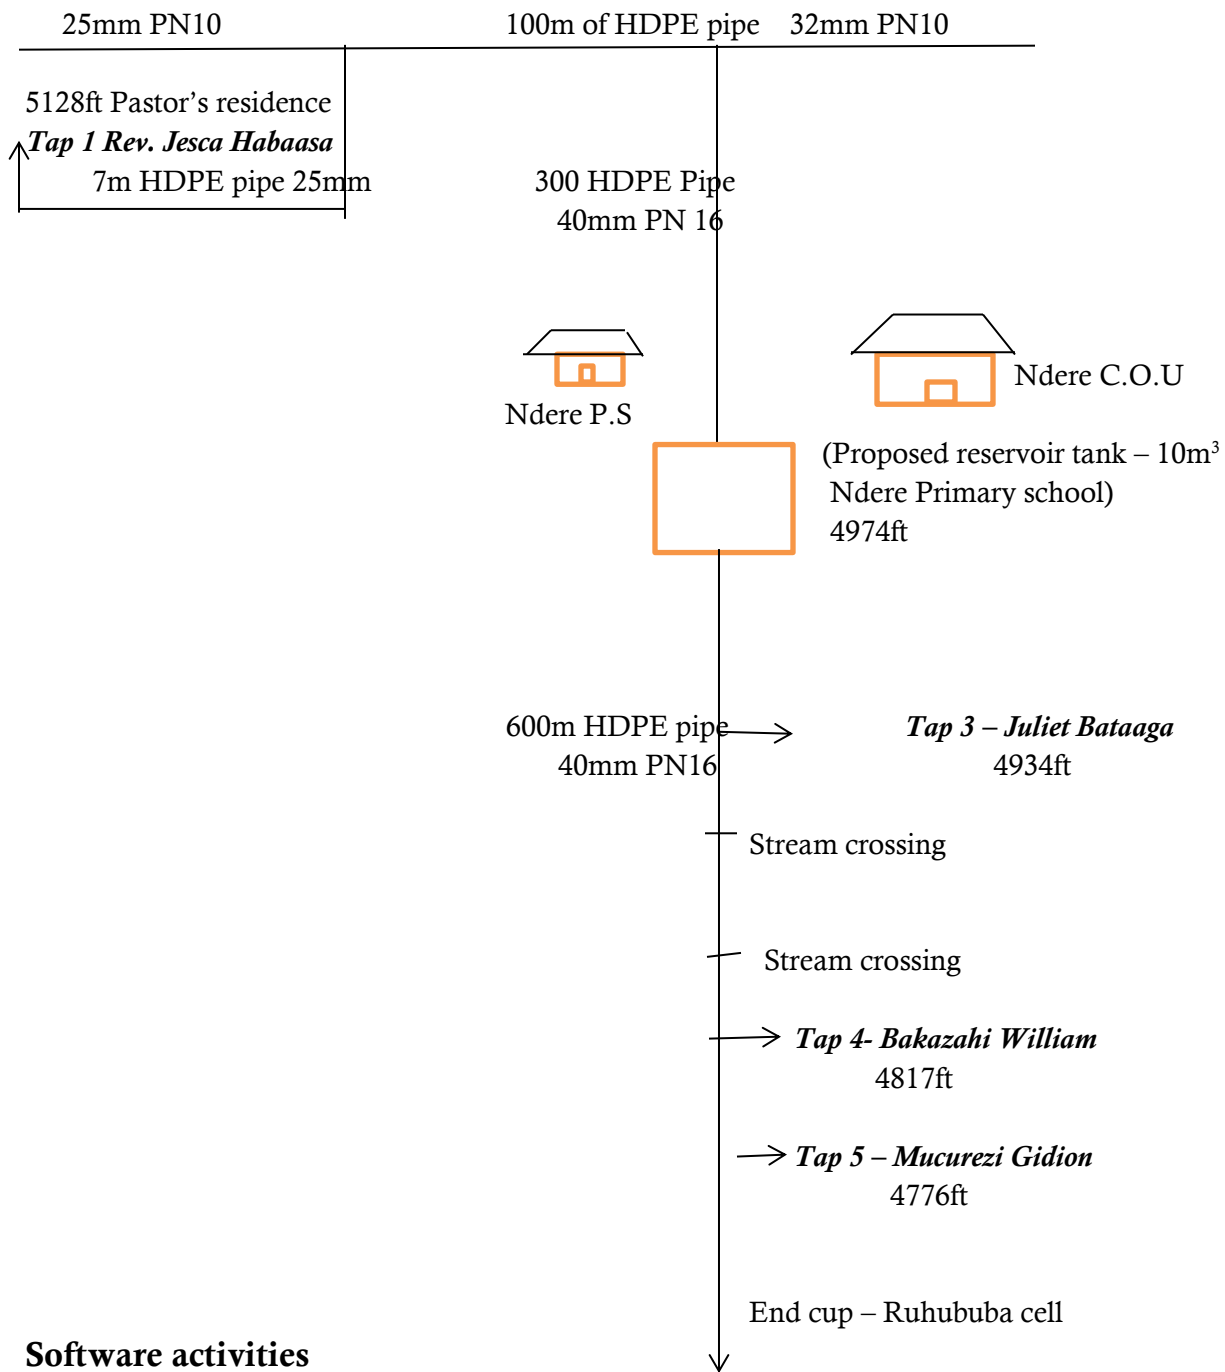
SCHEMATIC DRAWING FOR NDERE MINI GRAVITY FLOW SCHEME

2.2. System description

3 No. spring eyes

Source yield 0.1 litres/sec (8640 litres/day)

1 No. sedimentation tank 5,000 litres

1 No. reservoir tank, 10,000 litres

5 No. single faucet tapstands

1144 metre pipeline

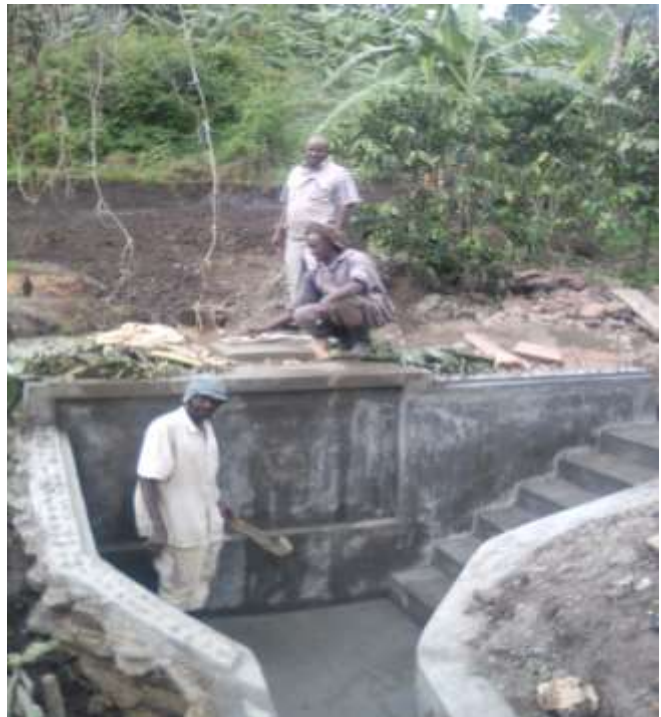
A low yield spring was constructed in Mabanga, Kebisoni Sub County, Rukungiri district.

Supervision of Mabanga spring construction by Coordinator & his team slightly before it was finished in September, 2018

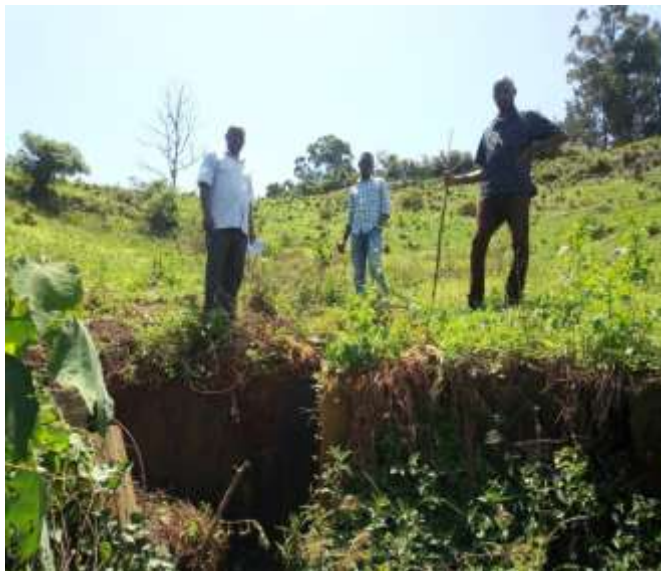
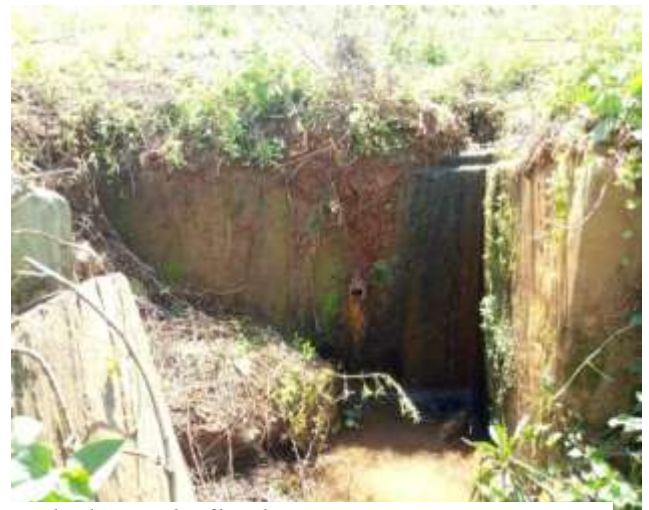
Two springs in Kanungu district in Nyakatare and Kambuga respectively were visited. One in Nyakatare was completely demolished by floods leaving the beneficiary community that includes Nyakatare primary school with no access to clean water.

Another one in Ruhandagazi Katungu, Kambuga (Low yield spring) is in an appalling condition after its cover to the reservoir was broken and now its exposed to contamination.

The drainage channel was also blocked and the water is stagnating in the fetching chamber.

The tap-heads were removed and now water is flowing uncontrolled.

Nyakatare spring - washed away by floods

These two springs should be of potential interest if funds are available for spring rehabilitation.

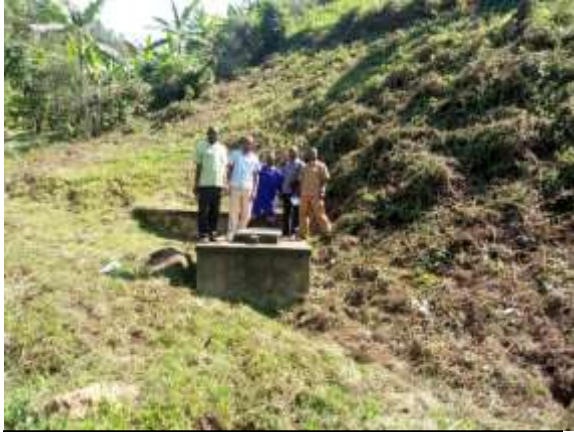
S/N	AREAS VISITED	OBSERVATIONS MADE	RECOMMENDATIONS MADE
1	Sedimentation tanks	<ul style="list-style-type: none"> • Only one inlet pipe brings in water • Sanitation in the tanks is good • Flow rate of water through the pipe is good • No locks on the main hole covers 	<ul style="list-style-type: none"> • Padlocks to be bought and chambers locked • Need to keep cleaning the tanks • Need to open the tapping point for the 2nd pipe line to ensure

The Kinkiizi link person and Nyambizi GFS O&M committee while at the Nyambizi GFS sedimentation tank

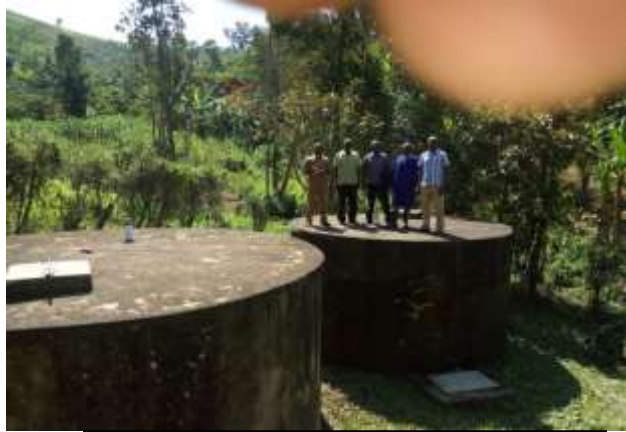
While at the Distribution/Reservoir tank

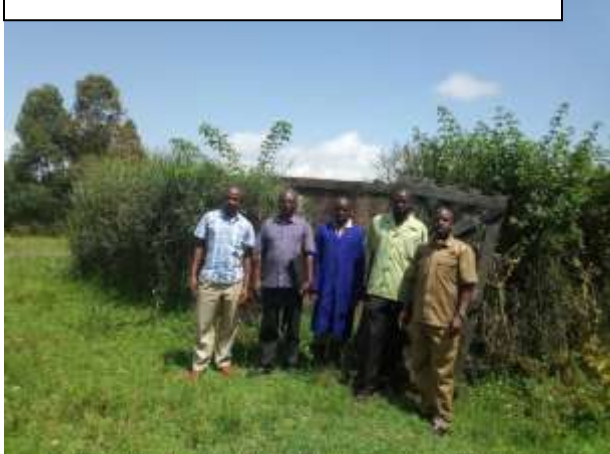
4	Distribution tanks at Katojo T/C	<ul style="list-style-type: none"> • Sanitation is moderate • Fence around the tank is strong • Manholes for inspection were broken • The tank had water almost ¾ full • The vent pipe is broken • No locks on the inspection covers • Gate valves are also direct. i.e. cannot lock 	<ul style="list-style-type: none"> • Vent pipe (Air breather) needs to be replaced • Manholes around the tank need to be rebuilt • Locks need to be bought • Gate valves need to be replaced
5	A Few Selected Water Tap Stands- Kanyamisinga	<ul style="list-style-type: none"> • Water moves from distribution tank up to the 2nd water tap stand • The 3rd tap stand and beyond do not receive water • A suspect Air locks/ leakage should be on the line 	<ul style="list-style-type: none"> ○ Need a fresh technical survey about the water line from the Distribution tank at Katojo T/C heading to Kanyamisinga where the furthest tap stand is located

While at the Reservoir tank at Katojo T/C

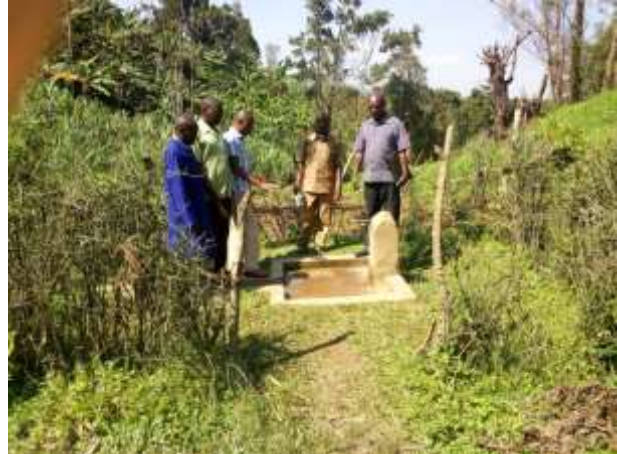
While at the Community water tap stand
