**NORTH KIGEZI & KINKIIZI DIOCESES WATER AND SANITATION  
PROGRAMME (NKKD WATSAN)**

**3<sup>rd</sup> Quarterly Report  
July - September, 2019**

### **C.1 Kihihi Hill Rain Water Harvesting and Sanitation Improvement Project (Kihihi Hill Project)**

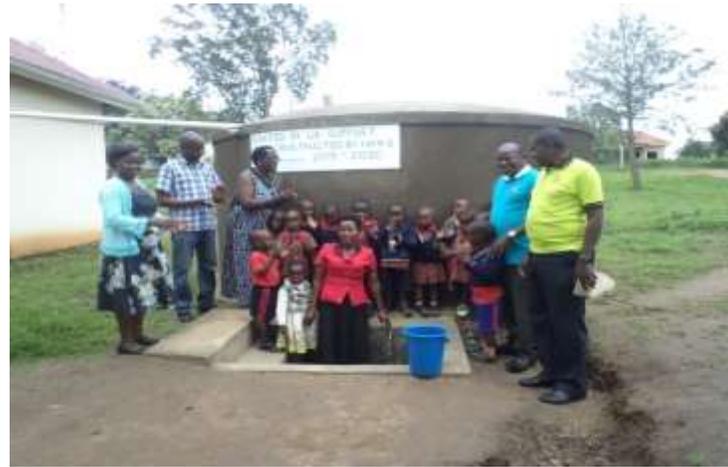
**WATSAN supervisors, Kihihi Archdeacon and Kihihi Kindergarten children and teachers (direct beneficiaries) pose for a photo at the finished tank.**

A 30M<sup>3</sup> RWH tank was constructed to completion, and is situated adjacent to the Kihihi Archdeacon's office whose roof feeds this tank with rain water.

- Site clearance
- Excavation and level to firm in bolder soils up to 0.5metres and deposited the excavated soils from the site.
- Hardcore filling in the foundation thickness of 0.3metres, compacted and blinded.

- Base construction up to 0.3metres
- Plumbing works (pipes and fittings assembled, that includes the overflows, washout and outlet pipes.
- Placing of the reinforced concrete cement in ratio of 1:2:3 for the floor thickness of 210mm.

- Provision of high yield twisted iron bars 10mm and a roll of RBC mesh and two rolls of chicken mesh for walls.
- Placing mortar masonry works in ratio of 1:3 for walls in two layers

- Cement punning with pure cement inside the tank up to the height of 2metres from the floor.
- Plastering outside the tank in two lays of 25mm in ratio of 1:3 sand cement plaster total thickness on 50mm.

- Providing a roll of RBC mesh and two rolls of chicken mesh for roof
- Placing of reinforced mortar sand-cement in a ratio 1:3 for the roof
- Placing the iron man hole cover including locking arrangements

- Rough casting outside the tank
- Backfilling with ordinary soils, cleaning and shaping the area.
- Providing and connection of a ¾” brass tap
- Guttering and collection of rain water using PVC gutters and 3” PVC pipes down to the newly constructed tanks.

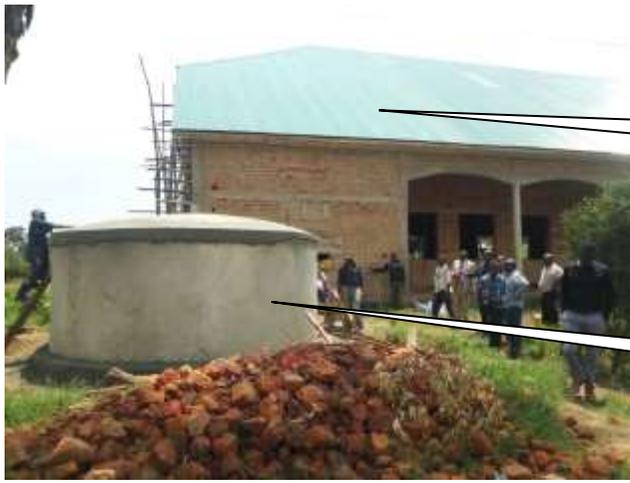
Roof of the school main hall building where rain water is going to be collected from

A 30m<sup>3</sup> Rain water Tank under construction

This tank is situated near the school main hall from whose roof, rainwater catchment will take place to deliver water into this tank.

The construction process of this tank is ongoing but nearing completion with the roof guttering and directing delivery pipes into the tank. It took the same construction process as the one at Kihihi Church.

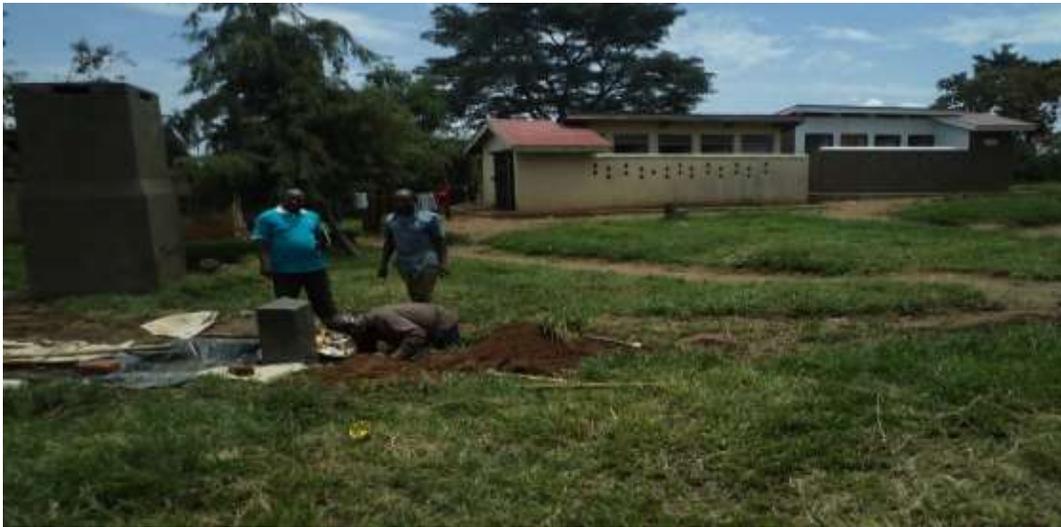
Connection of a single faucet tapstand constructed near Girls' Dormitory at Kihiki H/S to the rain water harvesting tank, being carried out at the school main hall.

For the accessibility of this rain water to girls who are intended to use it, a single faucet tapstand to provide the fetching point was constructed and finished 50m away from the tank in the girls' dormitory area. Then, there was pipe laying of the HDPE Pipes and then connection between the tank and tapstand.

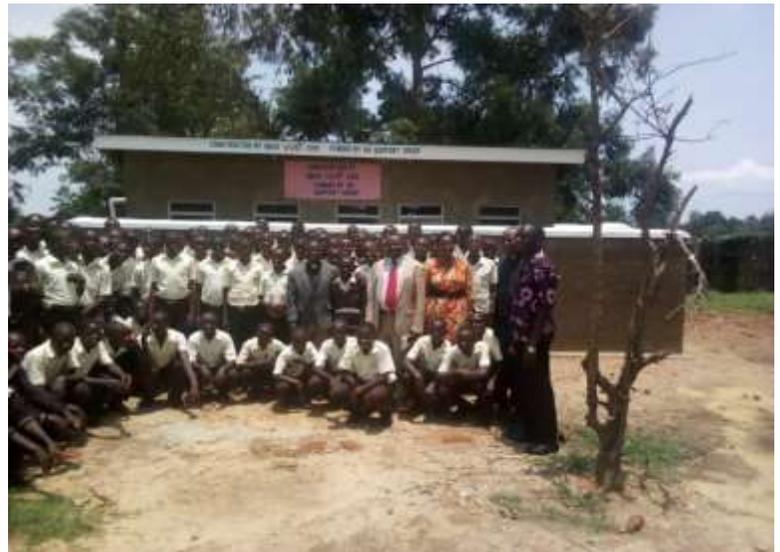
**Handover of the newly constructed 6-stance VIP latrine for boys at Kihiki H/S**

A 5-stance lined pit latrine with a urinal for boys was constructed at Kihiki High School. This is near the boys' dormitory.

**Pit lining:** Brick masonry works, and a ring beam at the Centre of the pit using high yield twisted iron bars 12mm, reinforced concrete mix in a ration 1:2:3.

**Slab construction:** Placing of timber boards, placing of high yield twisted iron bars 12mm, and reinforced concrete standard mix in ratio 1:2:3 leaving a man hole for the provision of emptying the deposited matter.

**Wall construction:** Brick masonry super structure and placing of door frames, Placing of vent pipes with vent cups, Roof construction: this includes placing of timber 4”\*2” and standard gauge of iron sheets, Plastering walls with sand cement mortar in a ratio 1:3, Painting the inside walls of the latrine, Placing of fascia boards, Construction of a concrete cover for the man hole, and back filling with ordinary soils, cleaning and shaping the area.

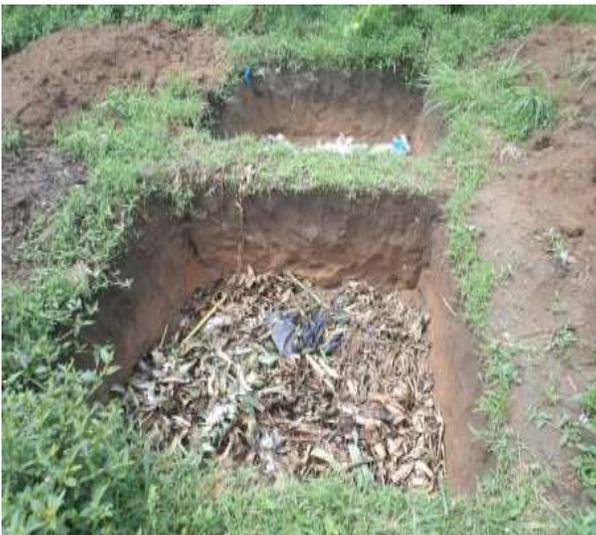
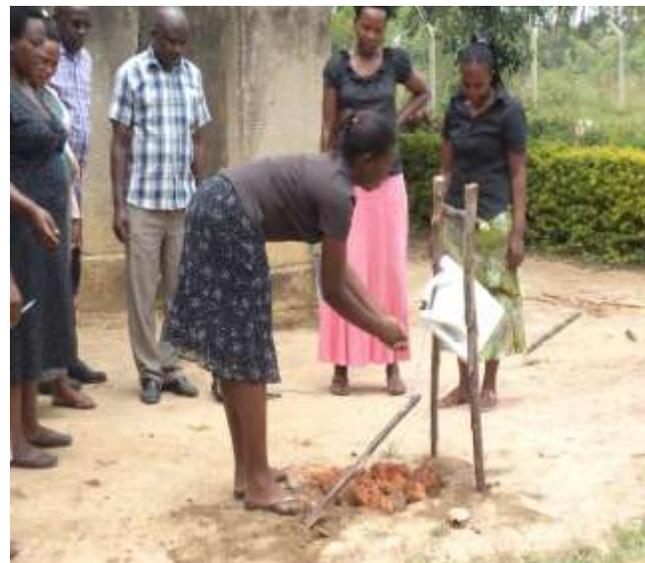
**A newly dug compost pit at the Nursery school teachers at Kihihi Archdeaconry practicing how to use a Hand's free tippy tap during hand washing**

Installation of two (2) tippy taps at the latrines and excavation two compost pits.

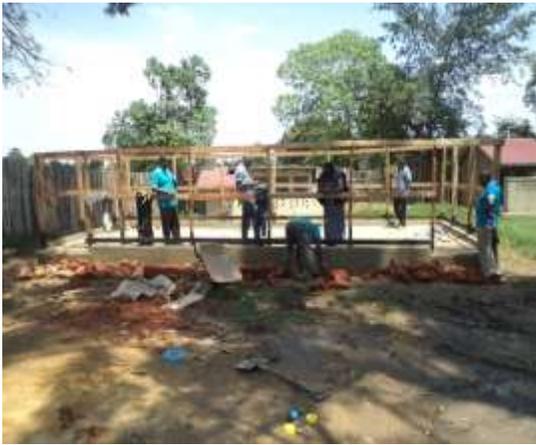
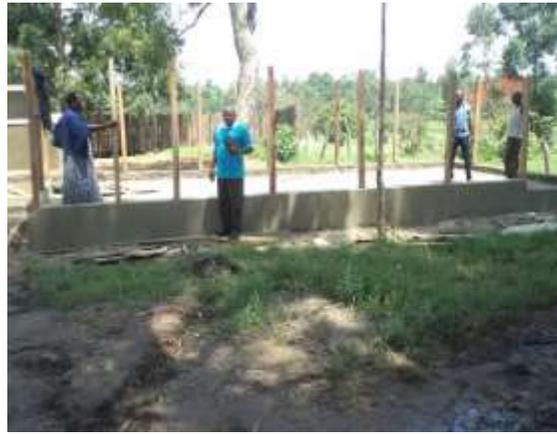
**Semi- permanent bath shelters under construction at Kihihi H/S**

2, the school started to construct two temporarily bath shelters but with concrete floors for boys. The Headmaster confessed to the Programme coordinator, Eric that *"the 6-stance pit latrine which you have put up for boys has become both a challenge to us and an encouragement too to put in more efforts and improve the sanitation situation for boys. So you see we are constructing improved bathing shelters for our boys and I hope this is going to attract more students to join this school!"*

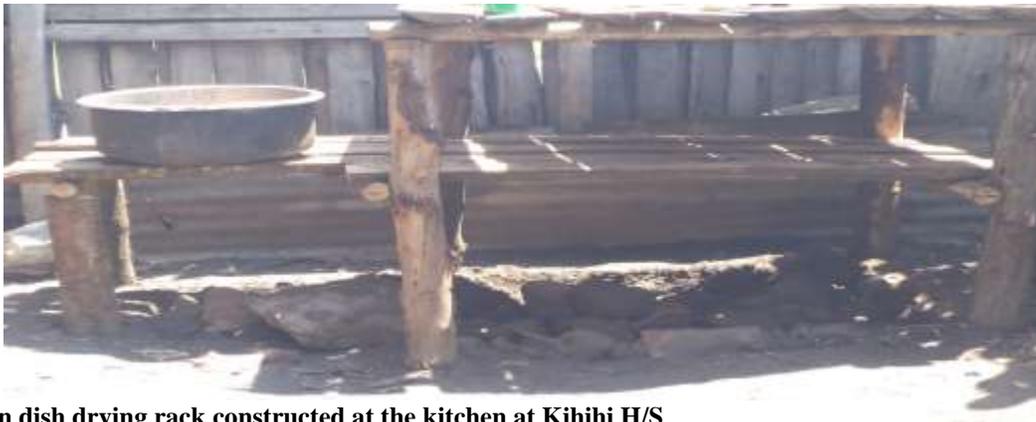
**A modern dish drying rack constructed at the kitchen at Kihihi H/S**

With guidance from the software staff, a standard dish drying rack was constructed at the kitchen at Kihihi high School.
