**NORTH KIGEZI & KINKIIZI DIOCESES  
WATER AND SANITATION PROGRAMME  
(NKKD WATSAN)**

**1<sup>st</sup> Quarterly Report  
January - March, 2019**

## **SECTION B: SITUATION REPORT – OVERVIEW**

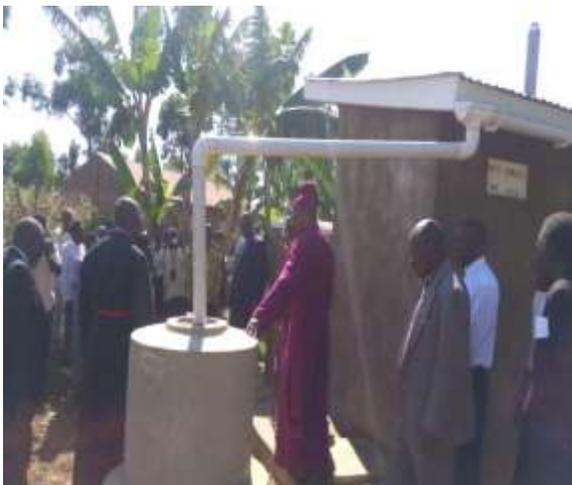
**A 5 stance boys Pit latrine with a urinal.**

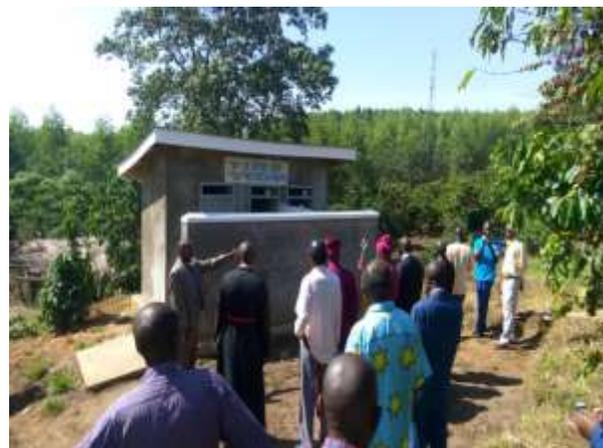
**2 stance Lined pit Latrines with a changing room for girls**

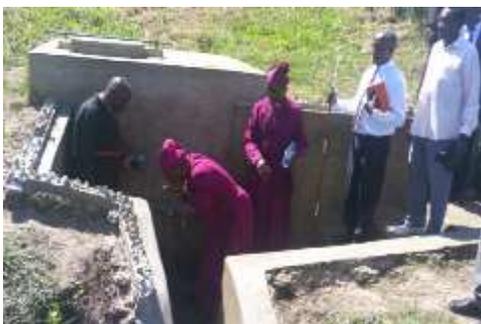
**Newly constructed Bwambara Low yield spring**

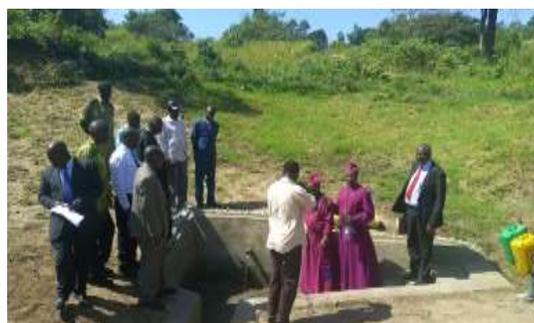
**Repaired Bwambara ordinary spring**

2018. Its yield had reduced and there was no fence around the spring. In preparation for this repair, the community was mobilized through several meetings at which the beneficiaries were urged to actively participate in the repair of the spring. As result, when the time came for the spring re-construction the community worked tirelessly to provide local materials and manual labour. The water was redirected into the delivery pipe which increased the volume significantly and the spring re-fenced. An operation and maintenance committee was selected and trained. This spring will help to reduce the congestion on the newly constructed low yield spring that was also constructed by NKKD WATSAN under the Bwambara hill water project.

1. Site survey. This was carried out to establish the detailed characteristics of the source, such as type, estimated flow rate and seasonal validation the water quality, number of users potation soil conditions around the source.
2. Spring capping. This involves developing the spring flow and protecting the eyes from the surface pollution. The spring eyes were protected cleaned all blockages from soil and other deposited matter, backfilled with graded gravel/aggregate, a layer of paddle clay 4” and heavy duty polythene paper sheet was placed on the gravel to protect the eyes from surface water. Live fence and grass was planted to prevent it from animals.

After the spring repair, re- fencing of the catchment area was carried out. This intended to stop animals from grazing in the catchment area which would cause compaction of this ground and interfere with the flow rate of the spring.

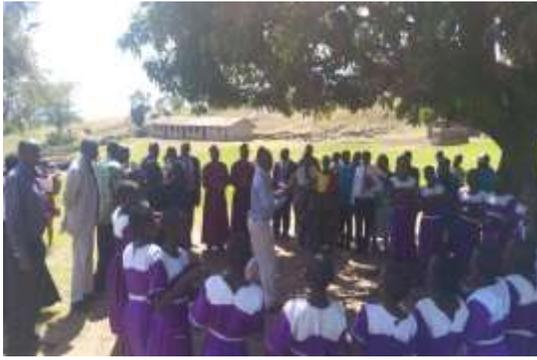
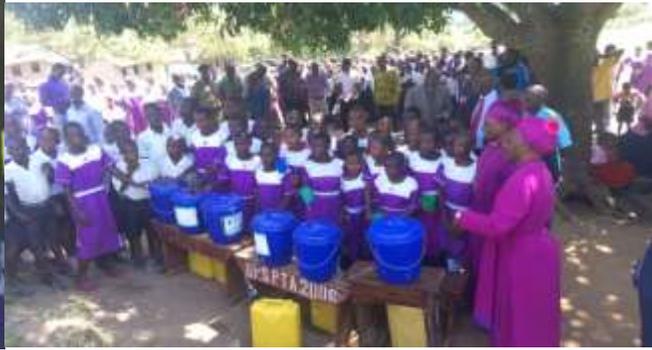
Welcome of the guests at the school. Demonstration of use water filters received from North Kigezi Diocese after having water in school.

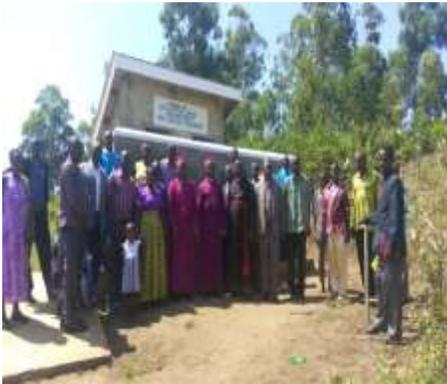
2 stance latrine with a urinal for staff

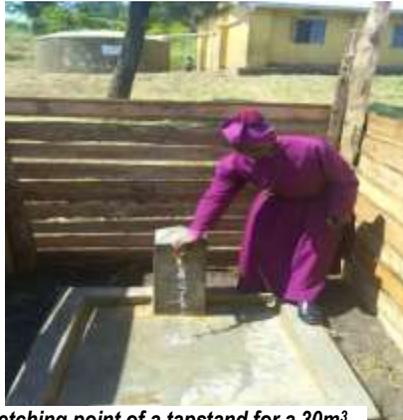
Fetching point of a tapstand for a 30m<sup>3</sup> Rain water harvesting tank in the school

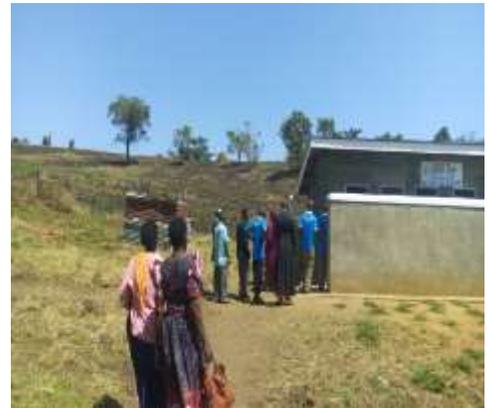
15 stance latrine with a changing room for girls

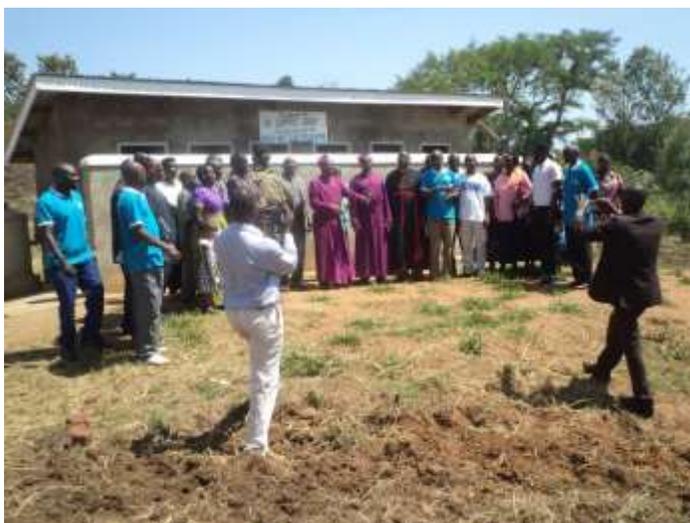
5 stance pit latrine with a urinal for Christians

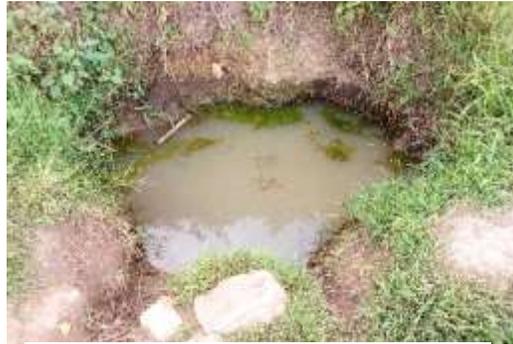
Kanyanga shallow well was constructed and completed in June, 2002. According to information from the user community, the shallow well worked for only about 2 years before it broke down. The community wrote to the sub county for technical advice and support but nothing was done. As a result, the shallow well was abandoned and they resorted back to dirty water holes, until recently when due to acute lack of clean water, the community continued to seek for assistance from the district and other organizations but in vain. Finally the community of Kanyanga approached NKKD WATSAN with a formal application requesting for technical support to repair the shallow well.

**A water hole at which the community fetched water before the repair of their**

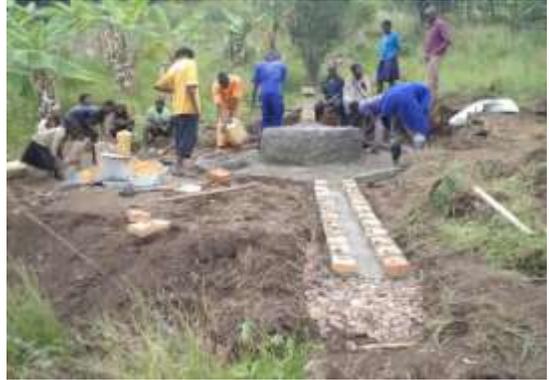
**Kanyanga shallow well during early stages of repair**

- (i) The site was cleared of the bushes and heaped soil around the shallow well.
- (ii) The existing plaster on the shallow well and apron was hacked off and a new layer of plaster was added.
- (iii) A new drainage channel was constructed.
- (iv) The existing rusted G.I riser pipe and rods were removed and replaced with UPVC plastic pipes and stainless steel rods which are rust free. Other parts like the cylinder, water tank and pedestrian handle were also replaced with new ones in accordance with the government recommended U.3 modified borehole pumping system.

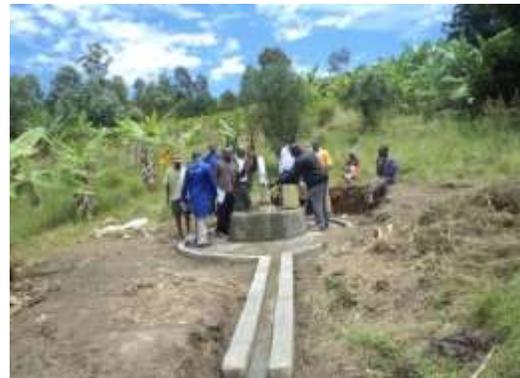
**Kanyanga shallow well during late stages of repair**

After the above mentioned repair works, the shallow well was put back to working condition with adequate water flow. Upon completion of this shallow well the community was very happy and excited to receive clean water once again.

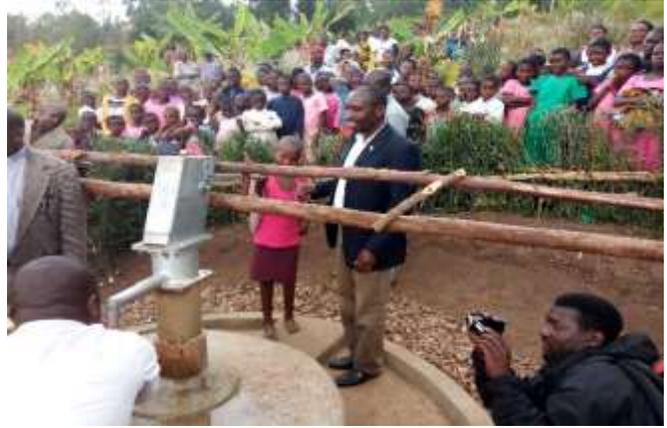
**A child demonstrates to the District water officer how to pump water at the shallow well**

1. An O&M committee was formed and trained to ensure proper maintenance of the shallow well.
2. A wooden guard was installed to regulate the pedestrian handle while pumping to avoid possible damages on the riser pipes and cylinder.
3. Regular follow up by NKKD WATSAN (Sustainability section) and other stakeholders like local government departments is to be carried out to support the beneficiaries in O&M of the shallow well.

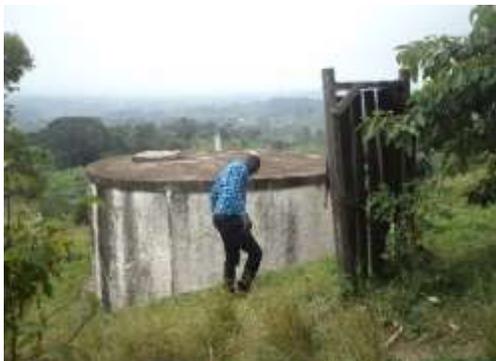
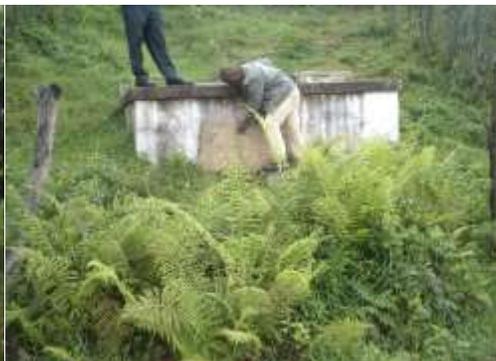
This scheme was visited and its functionality accessed. It was found that it is largely functioning well because all taps were capable of receiving water despite

some of them not being able to close or having minor leakages.

**A reservoir and sedimentation tanks whose fences have fallen**

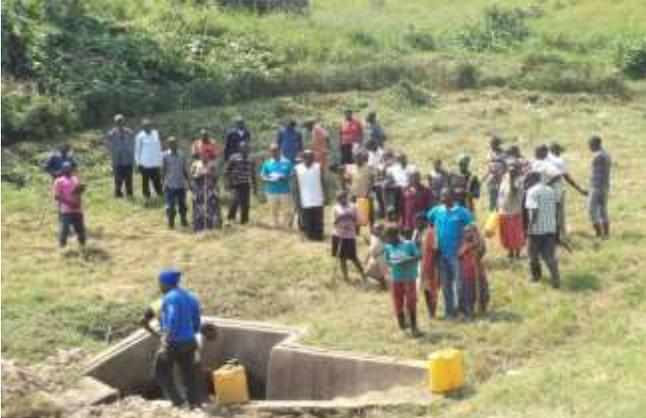
**Community members participating in the spring repair**

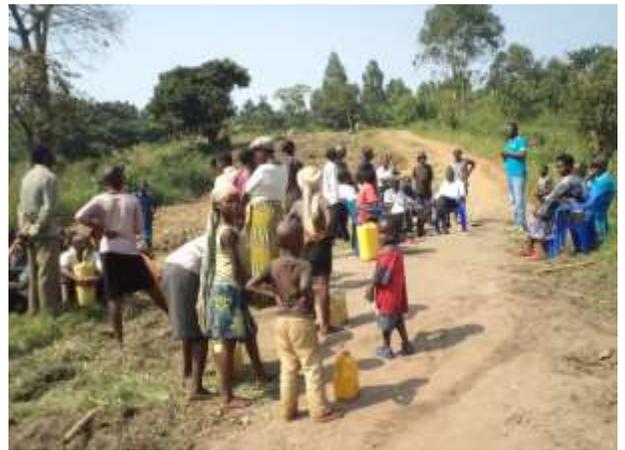
**A community meeting for Bwambara ordinary spring**

Repair of Bwambara ordinary spring undertook the following procedures:

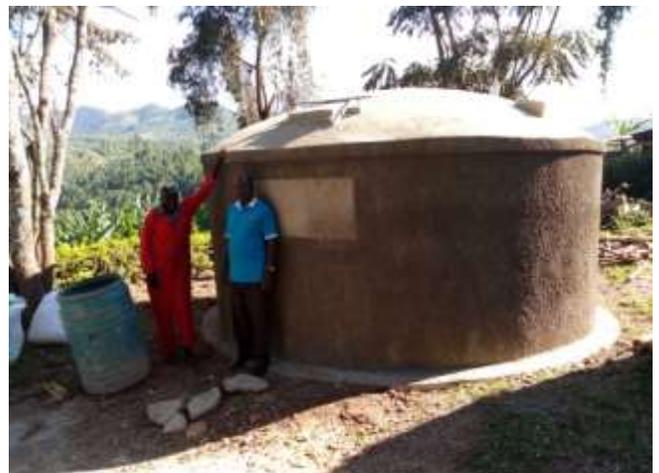
*The newly constructed Rain Water Tank at the Bishop's residence Nyakatara*

- Site clearance
- Excavation and level to firm ground in bolder soils up to 0.5 meters and deposited the excavated soils from the site
- Hardcore soiling thickness of 0.2 meters, compacted and blinded
- Base construction
- Plumbing works (pipes and fittings assemble) that included the overflow, outlet and wash out pipes.
- Placing of reinforced concrete cement in ratio of 1:2:3 for the floor thickness 210mm.
- Providing and placing of high yield twisted iron bars 10mm and two rolls of BRC mesh for the walls.

- Placing of mortar masonry works in (1:3) for walls.
- Plastering inside and outside the tank in two layers of 25mm in a ratio (1:3) and cement plaster final thickness of 100mm.
- Cement punning with pure cement inside the tank up to the height of 2 metres from the floor.
- Placing reinforced motor sand cement in a ratio (1:3) for the roof.
- Placing of man whole cover including cocking arrangements.
- Rough casting outside the tank.
- Backfilling with ordinary soils, cleaning and shaping the area.

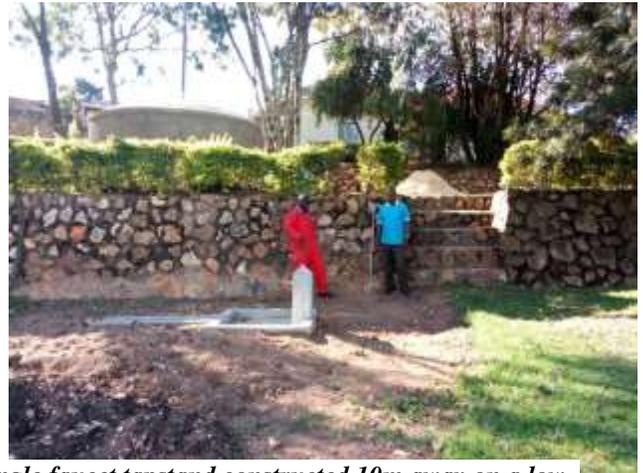
*Single faucet tapstand constructed 10m away on a low ground level of the Bishop's compound from the tank to serve as a fetching point*

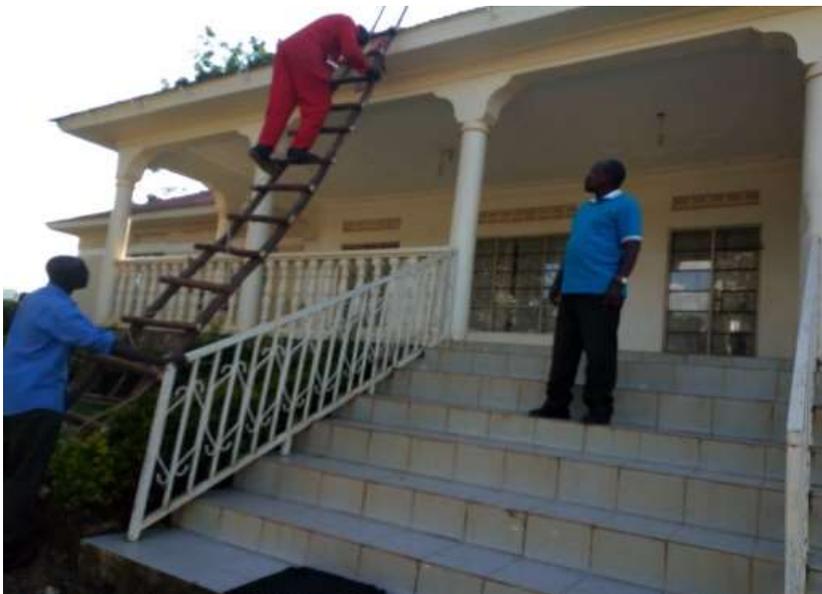
**Fixing of gutters at the Bishop's residential house to help in catching rainwater for the newly constructed tank**

- When tank construction was completed, the guttering process took place and roofs of two staff buildings were fixed with gutters to help in increasing water catchment supply into the tank.
- Also, a tap stand was constructed 10 meters away from the tank, to serve as a fetching point. Then, water connection between the tank and the tapstand was carried out.
